U.S.S. IOWA EXPLOSION

Sandia National Laboratories' Final Technical Report

U.S.S. Iowa Explosion

FINAL REPORT

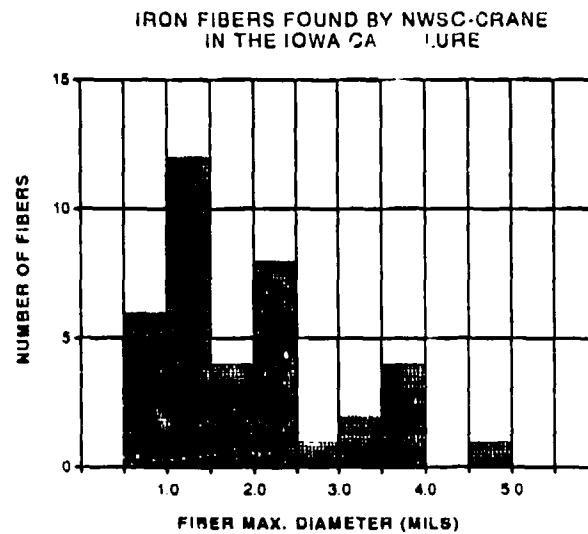
compared to the distribution of fiber sizes found in the IG-1 cannellure (Figure 3a). Within experimental uncertainty, these distributions are identical. Our conclusions from the fiber size data are that there is no difference in the sizes of the various fibers found in the cannellure and in the forward grooves of the IG-1 projectile.

Figure 3a. Size distribution of iron fibers found in the USS IOWA cannellure by NWSC-Crane.

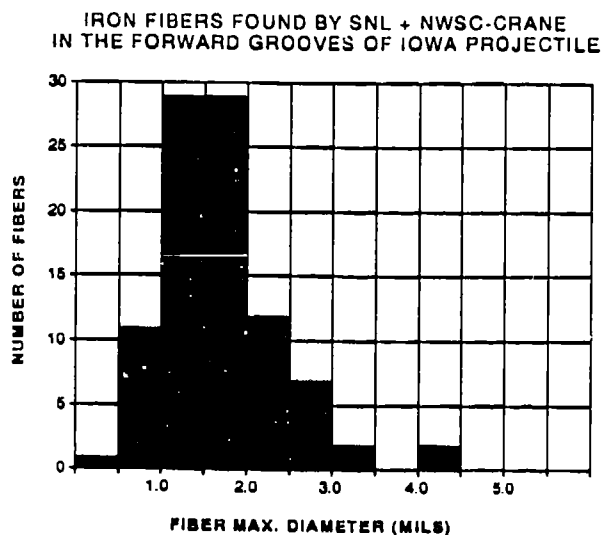
Figure 31. Size distribution of iron fibers found in the forward grooves of USS IOWA projectile (SNL + NWSC-Crane).

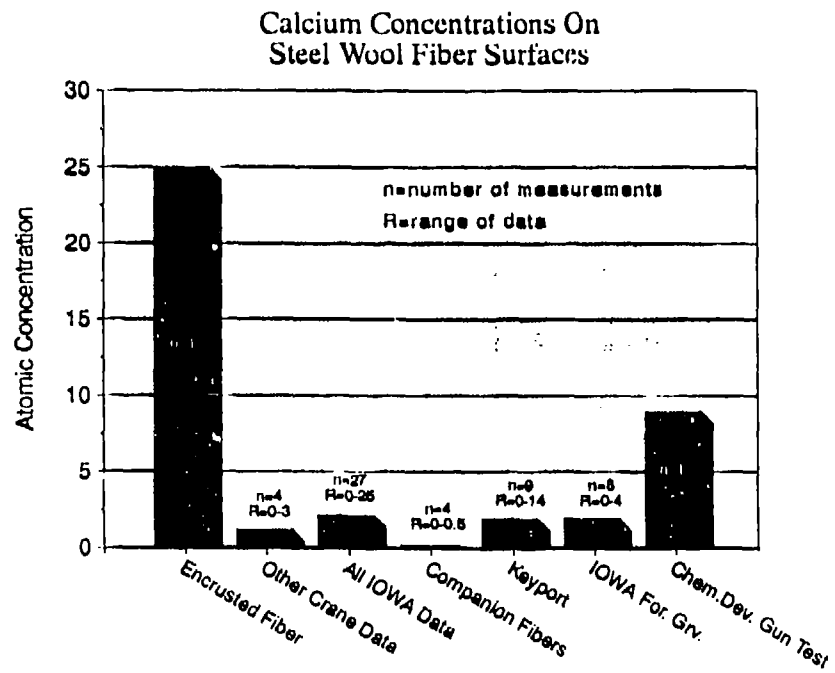
Subsequent to SNL's initial report, additional joint experiments were performed with NWSC-Crane to analyze iron fibers for Ca and Cl. In addition, all of the Energy Dispersive Analysis (EDA) data from SNL, NNSY, and NWSC-Crane with respect to Ca and Cl on iron fibers from the IG-1 cannellure were examined, (approximately 160 spectra in all). SNL also analyzed iron fibers from IG-1 and IG-2 forward grooves using Auger electron spectroscopy and electron microprobe analysis (EMPA). These data further supported the initial results; i.e., low levels of Ca and Cl are found on all of the iron fibers. This includes the fibers from the IG-1 cannellure and the forward grooves of both IG-1 and IG-2. Again, microscopic particles with high concentrations of Ca can be found. However, when the analysis is performed on a spot just a few micrometers from the particle, low levels of Ca are observed. Elemental distribution photomicrographs (EDPM) show that these particles are not associated with Cl.

Figure 5. Chlorine concentrations measured on steel wool fiber surfaces by Auger spectroscopy.

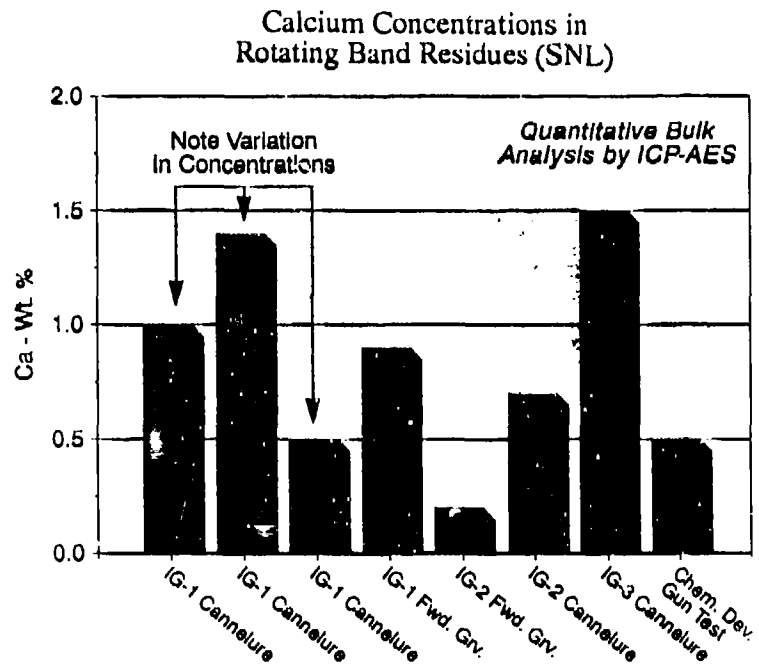
These data indicate the variability of the concentrations that can be measured in this nonuniform debris. They also indicate that the levels found in the IG-1 cannellure are generally consistent with those found in the forward grooves of IG-1, and on IG-2 and IG-3 and with those found on rotating-band cannellure samples from NSW-C-Dahlgren open-breech tests initiated with a chemical ignition device.

Figure 6. Calcium concentrations in debris from rotating bands.

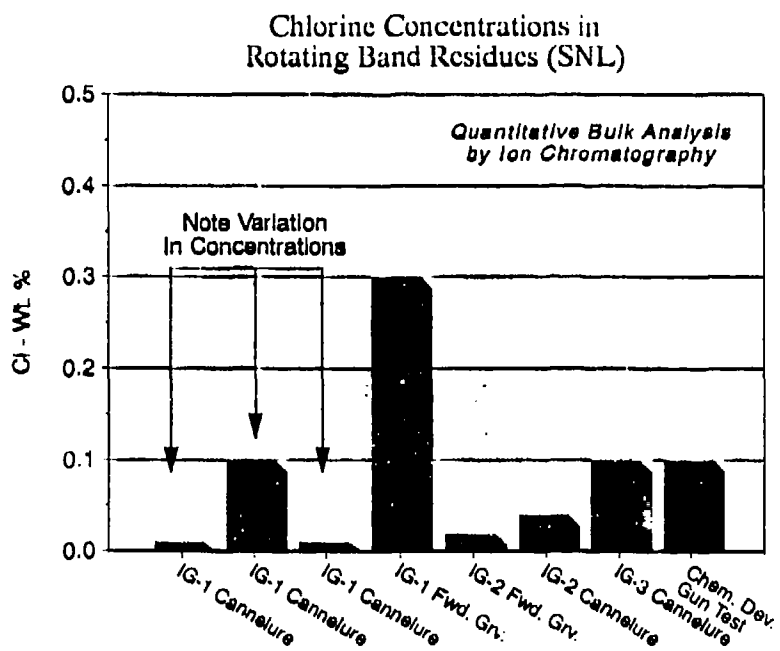
Figure 7. Chlorine concentrations in debris from rotating bands.

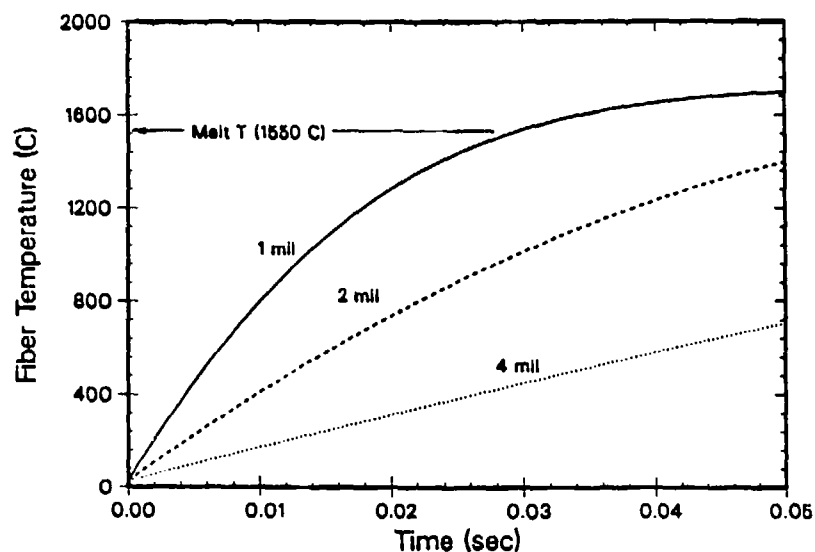
Figure 9. The temperature history of iron fibers with various diameters.

In summary, the propellant combustion environment produced sufficient heat transfer to partially melt small fibers and thus would have modified fibers originating within the powder charge. No recovered fiber exhibits a surface morphology indicative of intense heat transfer. It is concluded that the surface morphology of the iron "foreign material" fibers is not indicative of their having come from a hypothetical chemical ignition device in the propellant powder bags.

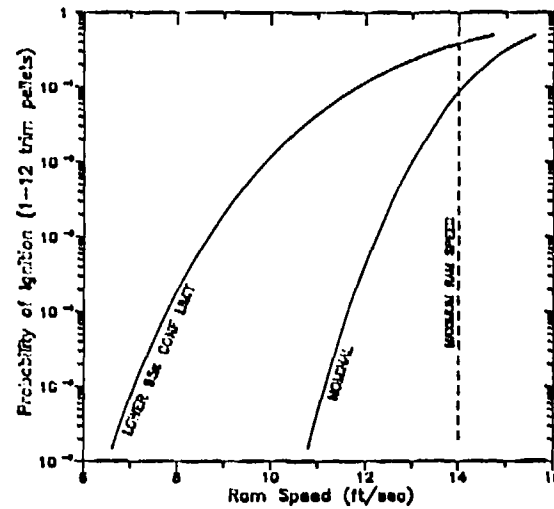
In either case, it is seen that there is a significant probability of ignition when a load of five bags with a small number of trim pellets in one of the bags is overrammed at high speed (but within the operating limits of the gun) into the base of a seated projectile. As the ram speed is reduced, so is the probability of ignition. Although the probability of ignition becomes extremely low at mid-range ramming speeds, it is not zero. It should be noted that in subscale tests (test Series No. 23, Table 1) ignition was obtained at 6.5 ft./sec. impact speeds.

Figure 12. Probability of ignition versus speed of ram (for five-bag load of D846 with one to twelve trim pellets in at least one bag).

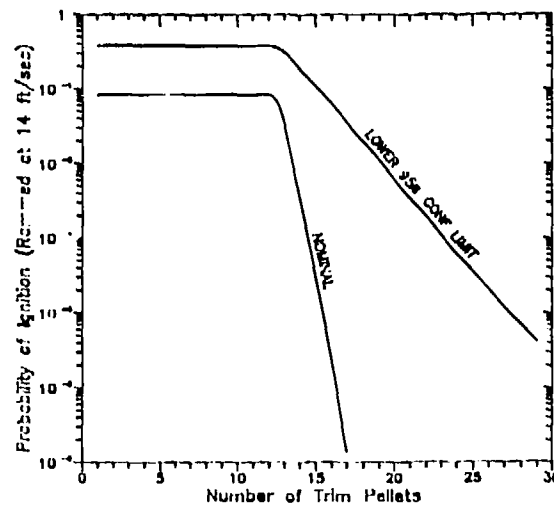
Figure 13. Probability of ignition versus number of trim pellets at ramming speed of 14 ft./sec.

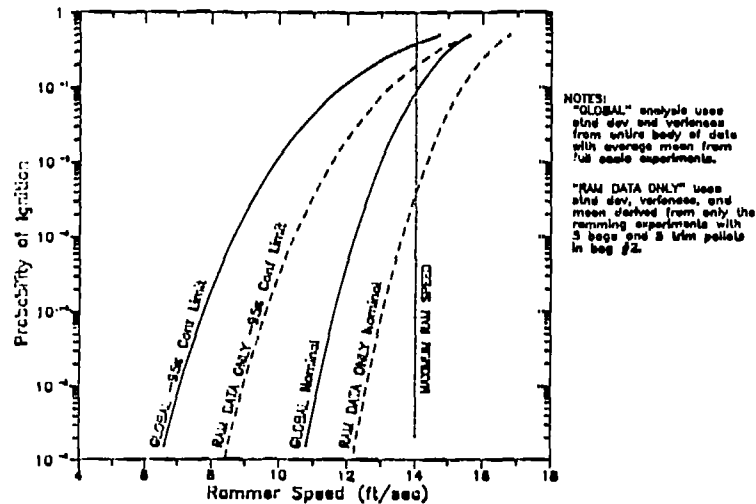
An alternative to the above analysis is to completely discount all of the subscale data, trends, and statistics and consider only the full-scale ramming tests where sufficient data were obtained to allow a statistical analysis of at least one single condition. The full-scale ramming tests of the five-bag load with five-trim pellets in the second bag is the only such data set. From Table 1, the mean, standard deviation and variances for this set have been determined and the statistical map of probability of ignition versus ramming speed calculated for the five-trim pellet configuration. These results are shown in Figure 14 where they are compared to the previous analysis that employed the global data set.

Figure 14. Comparison of ignition probability versus ram speed maps from global data and trends, to that from ram data for five bag/five pellets only.

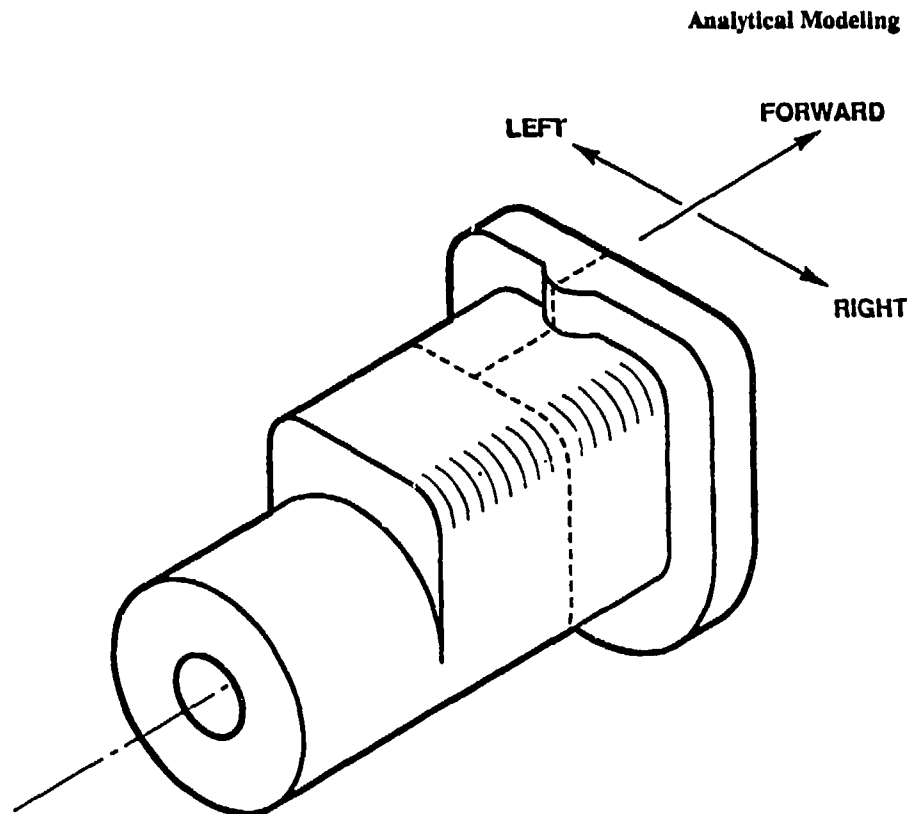
It was reasoned that the rammerhead might exhibit marks that would indicate the position of the rammerhead buffer at the time of the incident. To investigate this, the rammerhead was sectioned, as is shown in Figure 20. The forward section on the left side of the rammerhead was also cut horizontally near the center of the bore. Examination of the bore of the rammerhead buffer (Figure 21) showed two gouges.

It is concluded that these gouges and chips were produced during the incident and were not the result of ordinary wear, for two reasons. First, the chip on the left side has clearly been raised beyond the normal limit of buffer stroke. This requires that the spring break and, by a lateral offset of the broken ends, allow slightly more axial travel of the rammerhead relative to the piston. Second, the constant churning of fluid in the buffer should ultimately have caused the relatively delicate chips to bend, fatigue, and break off if they had been formed at an earlier time.

Figure 20. Orientation and sectioning of rammerhead.

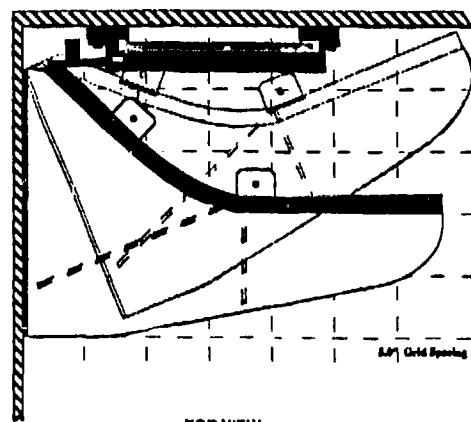
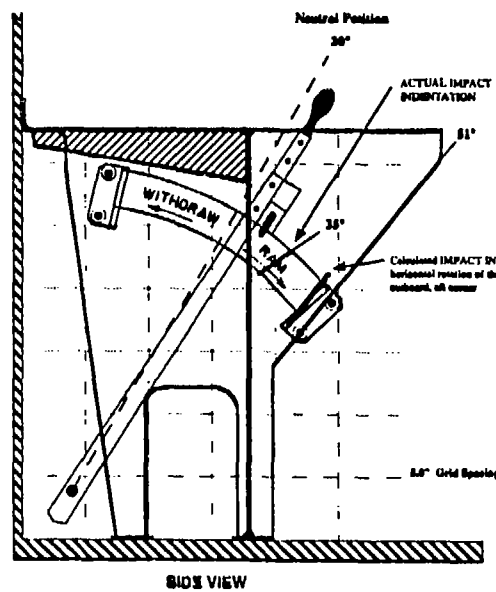
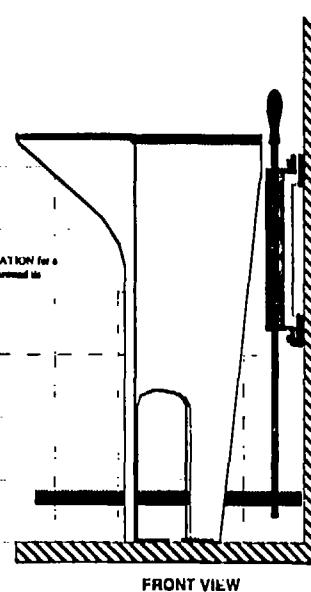
Viewed from above, the motion of the rammerman's seat was predicted to be a rotation of the seat about its outboard rear edge into the quadrant with the top of the seat remaining essentially horizontal during the movement (Figure 23). The time the seat impacts the quadrant after the start of the blast loading was about 15 msec. Thus, the forward edge of the seat impacts the quadrant at a speed of approximately 75 ft./sec. and at a very low angle, about 24 degrees between the plane of the seat plate and the plane of the quadrant. At such a low impact angle it would be expected that the unsupported leading edge of the rammerman's seat would be deformed. However, the only photograph (Figure 24a) that contains the leading edge of the seat shows no detectable deformation of the forward edge. Since the seat was discarded, detailed deformation and the "as-built" geometry cannot be definitively resolved.

Figure 23 also shows the relationship between the seat and the quadrant when viewed from the side. The front edge of the seat slopes upward at an angle of 51 degrees from the deck, beginning at a point about 19 3/4 in. forward of the rear gun room bulkhead. The indentation on the quadrant slopes upward at about 35 degrees from the deck and begins at a point about 18.5 in. forward of the aft bulkhead. Clearly, if the seat rotates into the undisturbed quadrant with its top remaining horizontal, it will not hit the quadrant at the right point or orientation to make the indentation noted on the quadrant.

Figure 23. Layout of rammerman station.

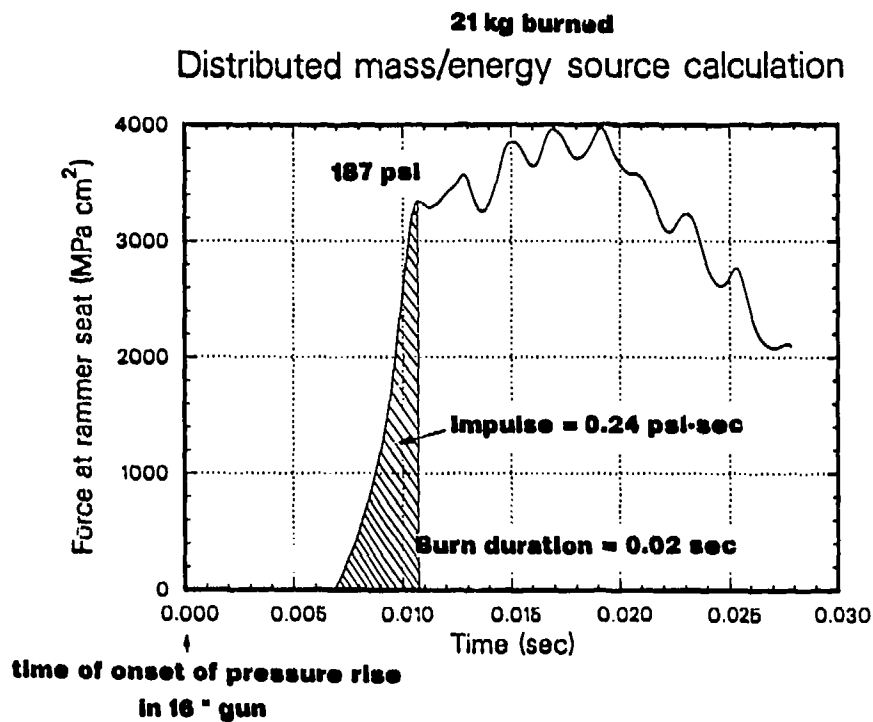
A plot of the pressure/history on the rammerman's seat is given in Figure 28. The peak pressure was estimated to be 187 psi, which occurred over 4 msec. of time. Because the pressure loading is due to gas flow impinging on the rammerman's seat, a loss of differential pressure occurs when the flow has arrived on the other side of the seat. It is thus assumed that no additional loading exists on the seat after this initial peak pressure of 187 psi.

Figure 28. Pressure at rammerman's seat predicted by distributed mass/energy source calculation. Note the absence of a pressure spike at the leading edge of the pulse.

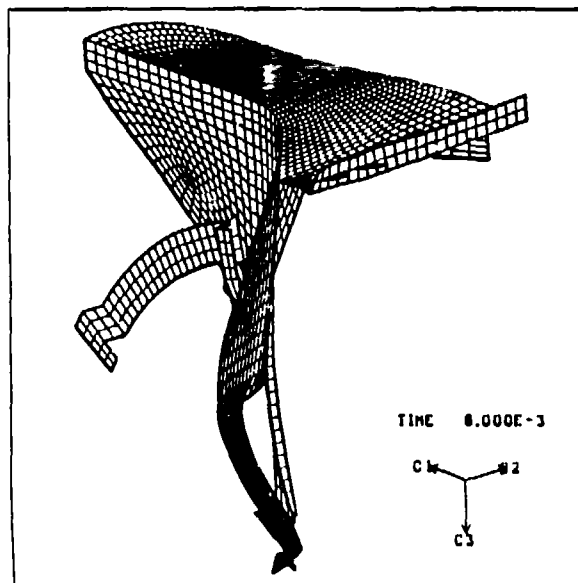
The results from the analysis show that the seat has translated and deformed over to the point of first contact with the quadrant at approximately 8.0 msec. after the initial loading. The seat plastically deforms and moves such that the first contact occurs at the lower aft mounting point of the quadrant. This is shown in Figure 32, which shows the deformed plot of the structure at this time from behind and to the side of the rammerman's seat (the bulkhead has been removed for clarity). The seat has deformed and extends over to the quadrant. Also, forward and outward motion of the seat is evident by the deformation of the bolts attaching the seat to the rear bulkhead.

It is seen that the seat has contacted the quadrant at the aft rear portion of the mounting pad. This is important because it corresponds with damage to the quadrant from the incident, where a bolt head was apparently removed and a flat surface was evident at this same position.

Figure 32. Predicted contact between rammerman's seat and aft end of quadrant 8 msec. after start of pressure loading.

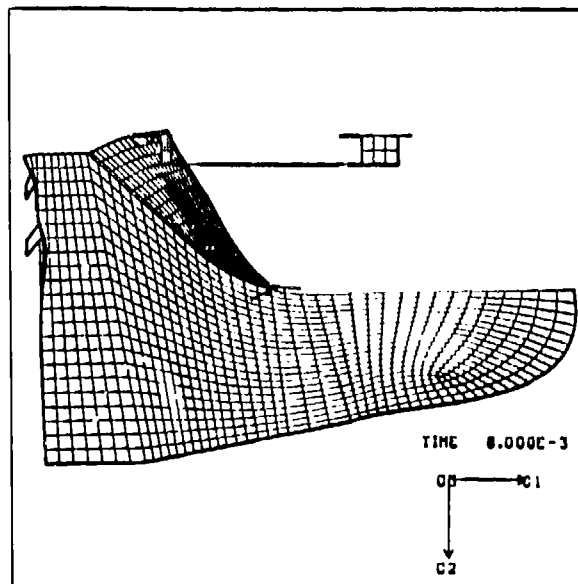
Of particular interest is the direction that the seat impacts the quadrant. Figure 33 shows the view of the seat from above. It is clear from this plot that significant forward directed forces exist on impact. The stresses shown in the plot are the VonMises stresses in these parts, and show that some yielding of the quadrant material has been caused by the impact. Because of these similarities with the physical evidence, it is concluded that these physical phenomena discovered from the analyses resemble the event and can be used to form the basis for a reasonable seat motion scenario.

Figure 33. Top view of seat when contact is first made with quadrant.

The seat appears to make first contact at the rear, underside of the quadrant mounting pad. Accordingly, there is a strong possibility that the quadrant would have been dislodged from the bulkhead early in the event. Deformation of the aft support leg of the seat causes contact with the rammer handle slightly before the seat contacts the quadrant. This means that the rammer handle would also have been knocked out position. From the photograph of the actual seat, the front edge of the seat appears undamaged, making it difficult to correlate the potential quadrant impact at the damage site. Large deformation of this edge would probably be necessary to cause damage to the quadrant. Also, the pressure loading is complex, making it difficult to definitively determine seat motion. Interaction of the aft leg and control handle appears likely. These factors all combine to make the damage to the quadrant an inaccurate indicator of the ramming speed.
